Inspection Order No. : IN-TJ-5301-12116
BOSS No: 1126376
Page No. : 1 of 11
Date of issue: Aug 31 2012

INSPECTION REPORT
 (non-negotiable)

- Description and Quantity of Commodity: Ductile pipe DN450
- Name & Address Of Buyer: L*****
- Name & Address Of Seller: SHANXI SOLID INDUSTRIAL CO.,LTD
- Inspection Date & Place: Aug 16~18 2012 Shanxi province, China.
- L/C No.: N/A
- P/I No.: SFC-1205A
- Nature Of Inspection:

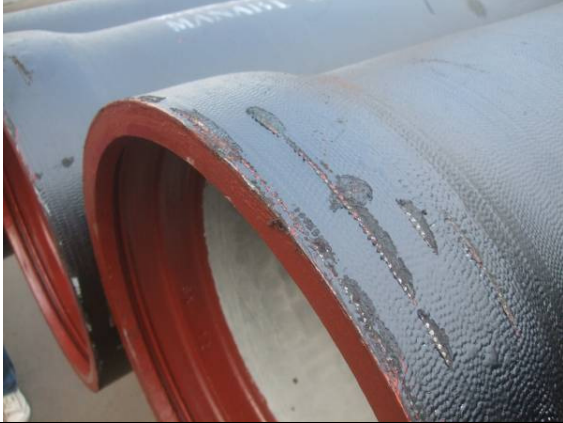
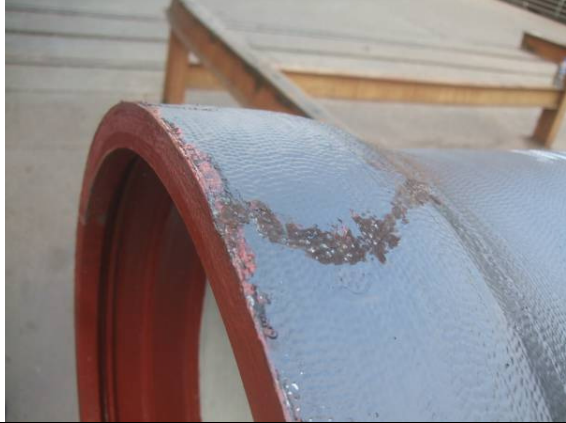
During inspection, the pipes were selected randomly for visual quality inspection. The pipes were found painted with black paint on external surface and lined with gray lining in internal surface, the socket of the pipe was found painted with red paint on internal surface. Except the 3pcs pipe coating scratched, no obvious defect on the visual quality of the pipes was found on site.

Coating scratched	Coating scratched

- ♦ The manufacturer declares that they will re-coat scratch area.

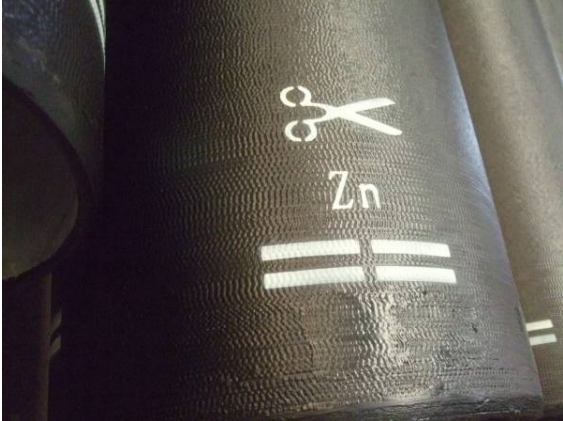
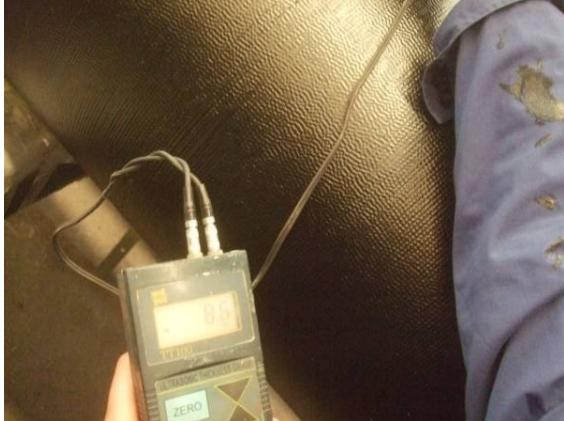
<p>Marking inspection</p>	<p>Wall thickness</p>

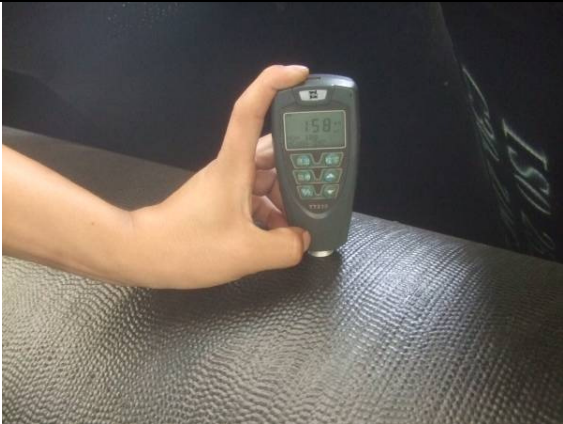
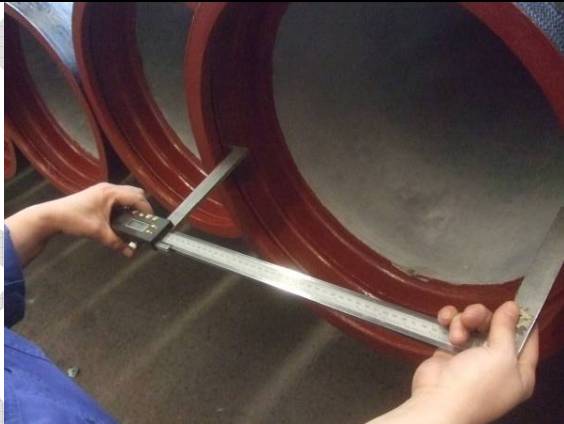
<p>Bitumen coating thickness</p>	<p>Inner diameter</p>

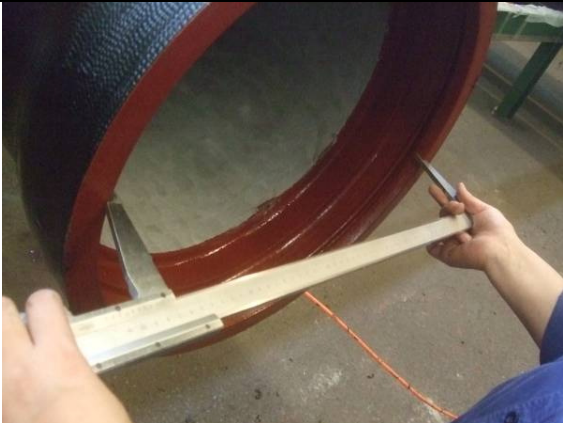
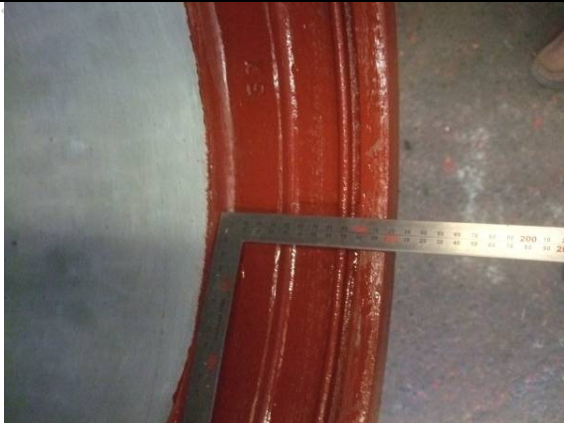
Remark: Except the no tolerance for T1, other dimension was in according with required value.

<p>Inner diameter</p>	<p>Socket depth</p>

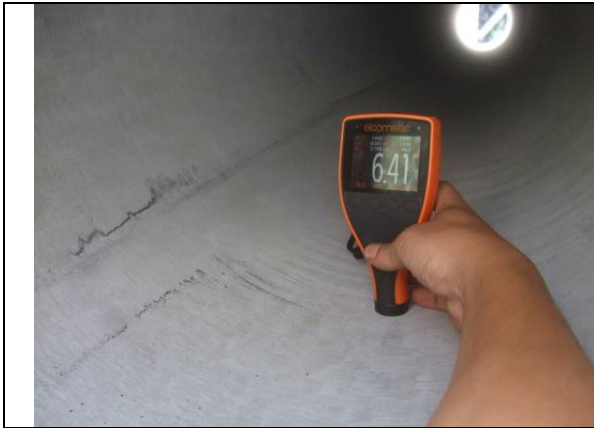
Cement lining thickness

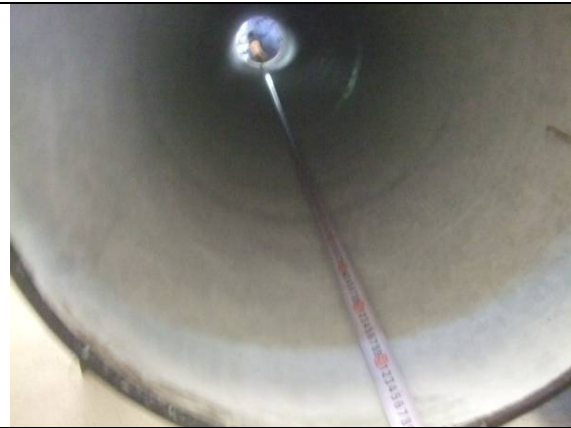
Length

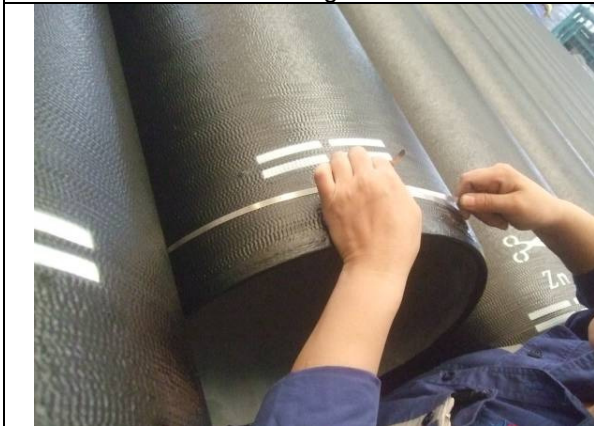
Out diameter
