Inspection Order No. : IN-TJ-5602-14099
BOSS No: 1220652
Page No. : 1 of 21
Date of issue: May 10, 2014

INSPECTION REPORT
 (non-negotiable)

- **Description and Quantity of Commodity:** Ductile Iron Pipe / 1211pieces
- **Name & Address Of Buyer:** C*****
- **Name & Address Of Seller:** SHANXI SOLID INDUSTRIAL CO., LTD
- **Inspection Date & Place:** On May 06~09 2014 at Gaoping Shanxi Province China
- **sales contract No.:** DATE : April 10,2014
- **Nature Of Inspection:**

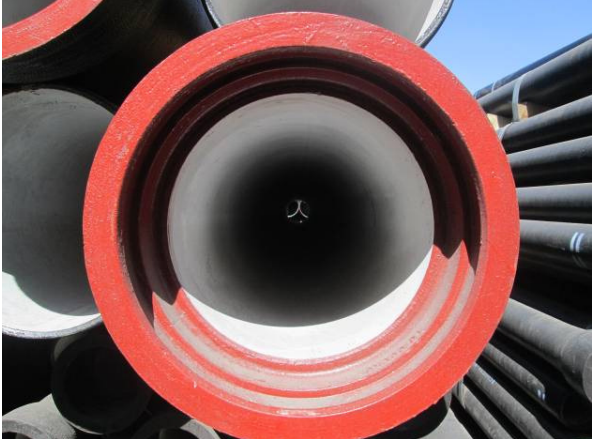
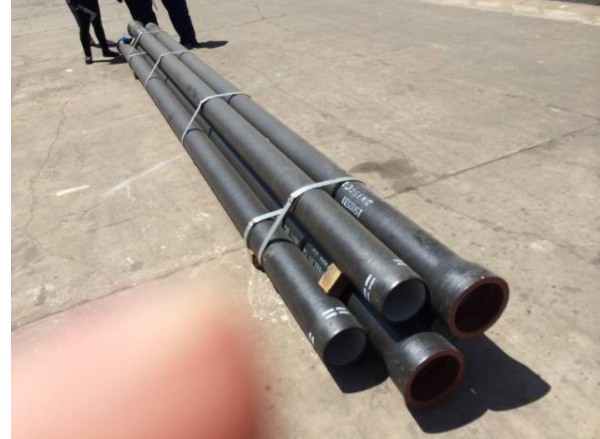
<p>visual quality check</p>

During the inspection, 136pcs pipes were selected randomly for visual quality inspection. The pipes were found painted with black coating on external surface and lined with gray lining on internal surface, the socket of the pipe was painted with red coating on internal surface. Surface condition of coating and lining was generally smooth. No obvious defects on the visual quality of the pipes were found.

Result: The result of visual quality was acceptable.

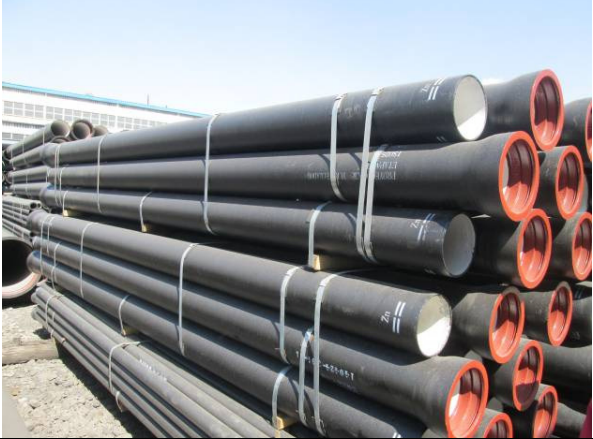
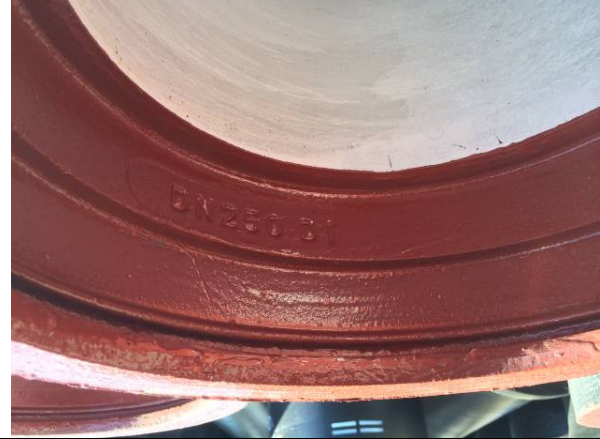
<p>Packing check</p>	<p>Marking check</p>

The pipes were bundled by steel stripes in bundle, and stacking with wooden block between per layer pipes.

Result: The result of packing check was acceptable according to sales contract (No.: proforma invoice No.: SFC-1401 dated April 14 2014)

Result: Except the cast marking in DN150 and DN300, the specified word content of actual marking was conformed to sales contract (No.: proforma invoice No.: SFC-1401 dated April 14 2014)

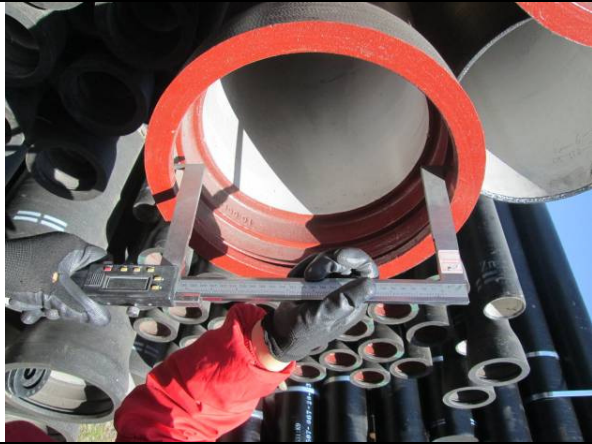
Dimension check

Result: The result of dimension check was acceptable.

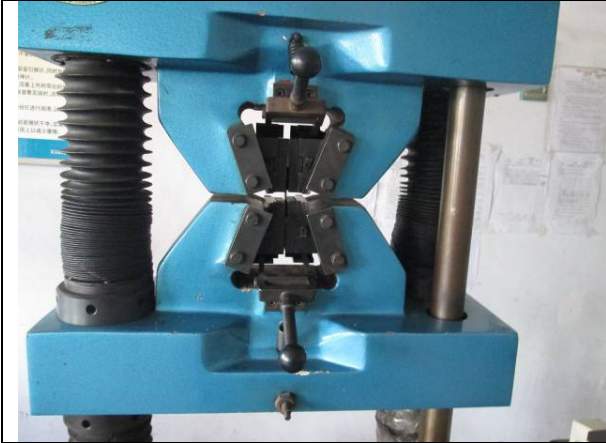
Witness tensile test

Result: The result of witness testing was acceptable.

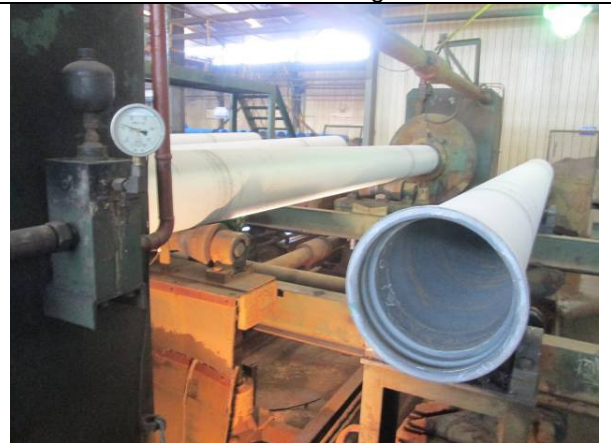
Hydrostatic test

Result: During the test, no visible leakage, sweating or any other sign of failure was found, the result of witness hydrostatic test was acceptable.

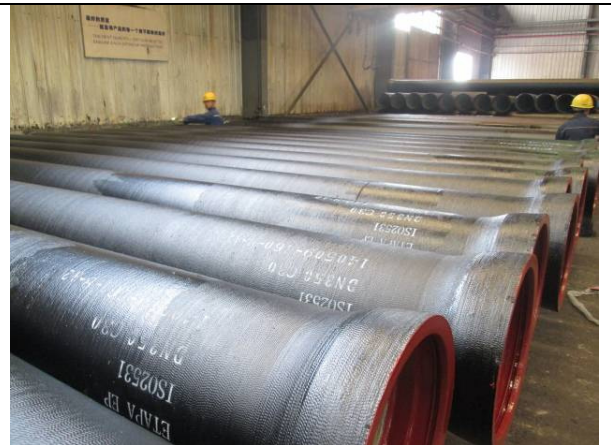
Visual quality

During the inspection, 22pcs pipes were selected randomly for visual quality inspection. The pipes were found painted with black coating on external surface and lined with gray lining on internal surface, the socket of the pipe was painted with red coating on internal surface. Surface condition of coating and lining was generally smooth. No obvious defects on the visual quality of the pipes were found.

Result: The result of visual quality was acceptable.

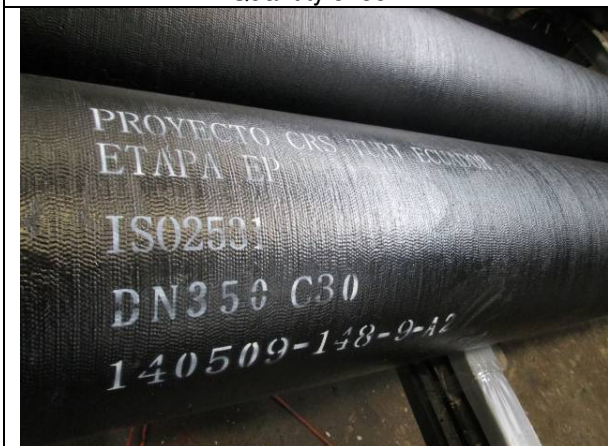
Marking check

Result: The specified word content of actual marking was conformed to sales contract (No.: proforma invoice No.: SFC-1401 dated April 14 2014)

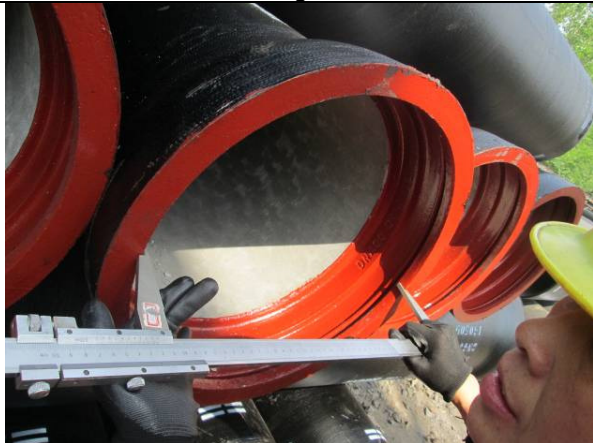
Dimension check

Result: The result of dimension check was acceptable.
