Inspection Order No. : IN-QD-PSI-09081  
Boss No.: 11991037  
Page No. : 1 of 6  
Date of Issue: July 10, 2009

**FIELD INSPECTION REPORT**  
(non-negotiable)

- **Description and Quantity of Commodity:** DI Pipes DN150 667pcs  
Rubber Gaskets 667pcs

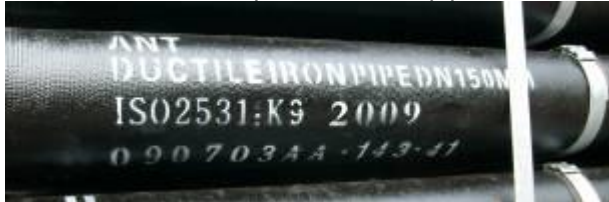
Found the mark was painted on the pipe surface as follows:

(Painted on socket side)

ANT  
DUCTILE IRON PIPE DN150MM  
ISO2531 K9 2009  
090707AA-143-41 (Pipe No.)

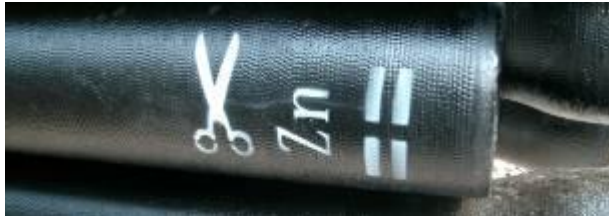
(Painted on spigot side)

(Cutting mark)

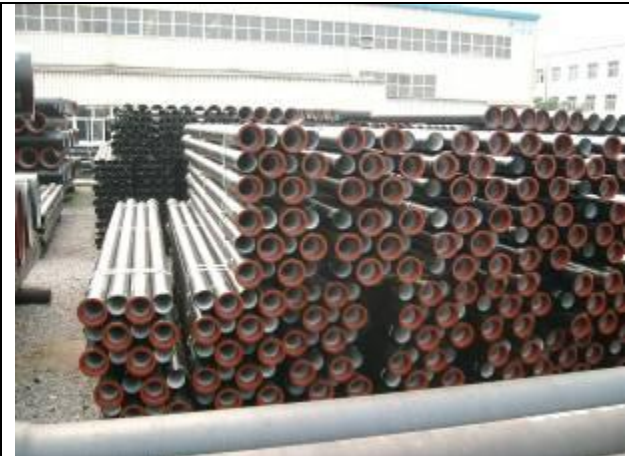
Found per 12pcs pipes packed as one bundle, each bundle secured and tightened by three iron belts at three places and each layers was separated by wooden battens.

**Pipes storied in the open air**

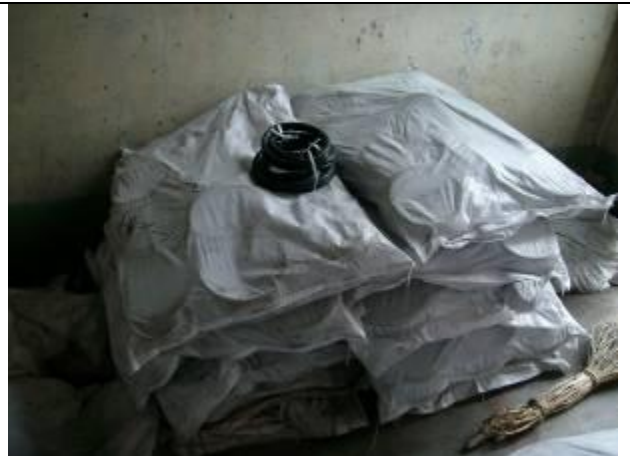
Found per 75pcs DN150 gaskets were packed in a plastic waved bags.

**Rubber gaskets storied in warehouse**

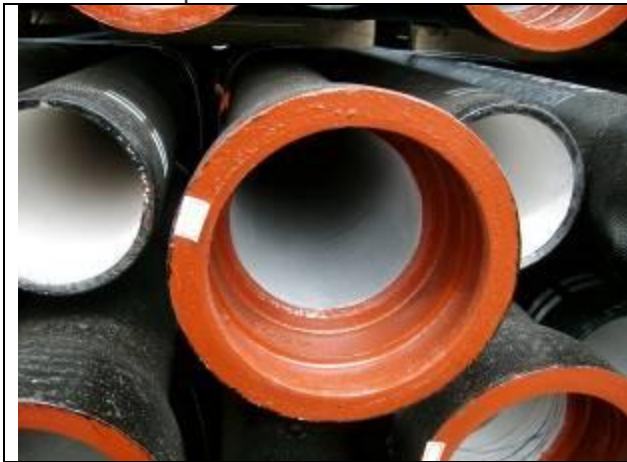
- According to the ANSI/ASQ Z1.4-2008 single planning for normal inspection Level II, total 80pcs pipes were selected randomly for visual quality inspection.
- Found inside of pipes were cement mortar lined and cement lining surface were even and smooth and without obvious crack, shedding; outside of pipes were bitumen coated uniformly and no obvious hole & pinhole was found.
- The 80pcs DI pipes inspected were new and visual quality was in sound condition.

<p>Visual from socket</p>	<p>Visual from spigot end</p>

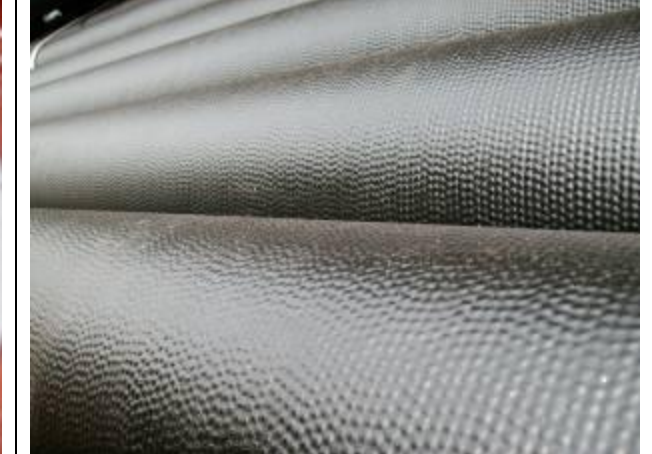
<p>cement mortar check</p>	<p>Coated Bitumen check</p>

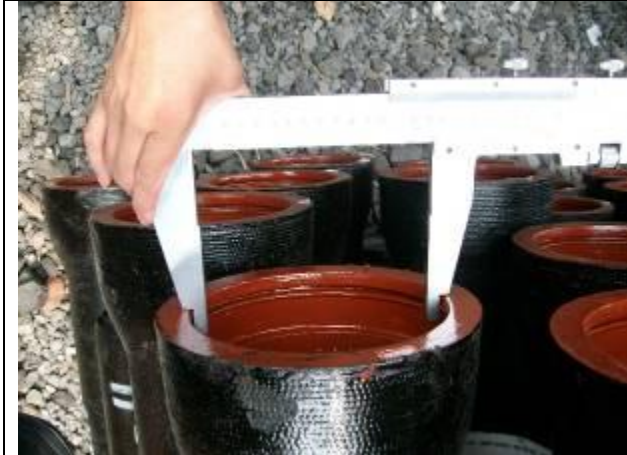
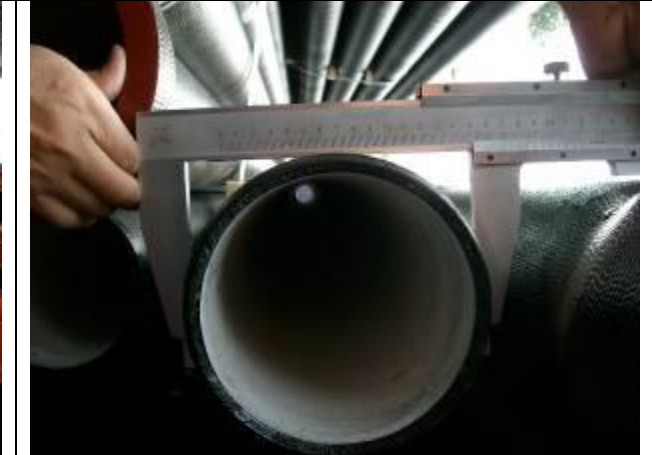
Check point	DE	D3	P	L	e	Tc	t (um)
Standard	170	172.5	94	6000	6.0	≥3.0	≥70um
Tolerance	+1/-2.9	+/-1	+/-5	+/-30	-1.3	/	/
1	169.5	172.3	93.5	6030	8.0	4.5	91
2	169.8	172.1	93.0	6010	6.7	3.8	104
3	169.6	172.3	94.0	5985	7.1	4.2	99
4	169.3	172.9	93.0	6030	7.2	5.3	114
5	169.9	173.3	94.0	6030	7.5	5.1	106
6	169.2	172.6	94.0	6026	6.4	4.6	108
7	169.4	172.9	94.2	6028	8.3	3.2	110
8	169.6	172.7	93.5	6030	7.2	3.3	120
9	169.8	172.9	94.0	5995	6.9	4.2	114
10	169.6	172.6	94.5	5995	6.5	3.6	97
11	168.3	172.7	94.0	5986	7.0	5.2	102
12	169.6	172.6	94.0	6000	6.5	3.8	108
13	169.8	173.0	94.0	6025	6.4	3.5	116

Result: Passed.

<p>Dimension check for "D3"</p>	<p>Dimension check for "DE"</p>

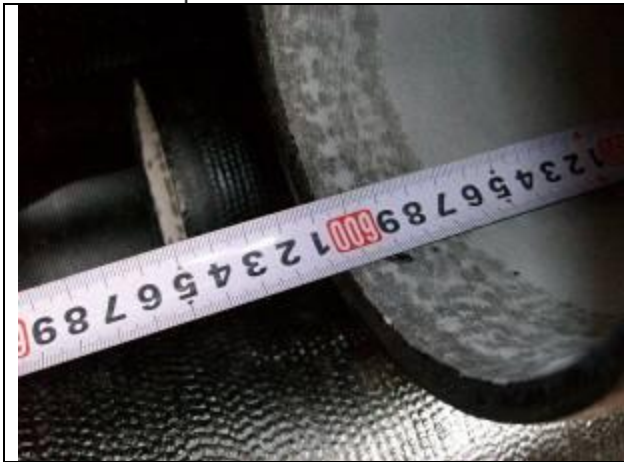
Dimension check for "L"

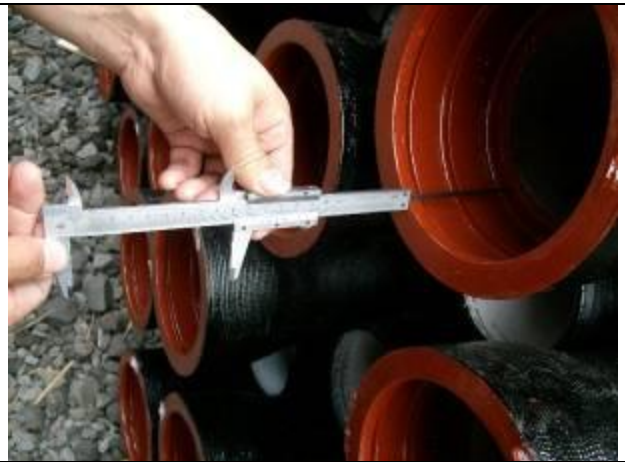
Dimension check for "P"

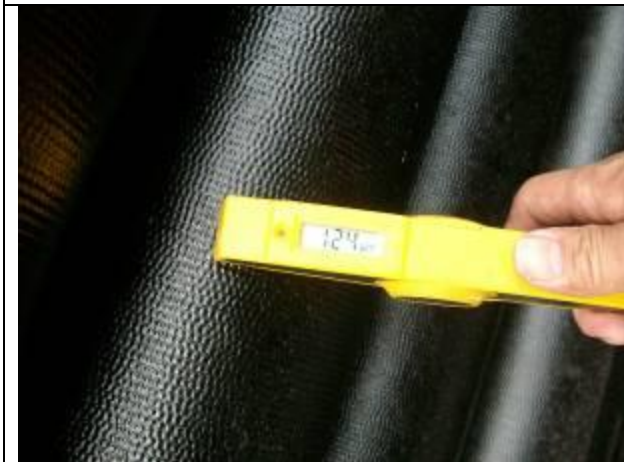
Bitumen coating checking

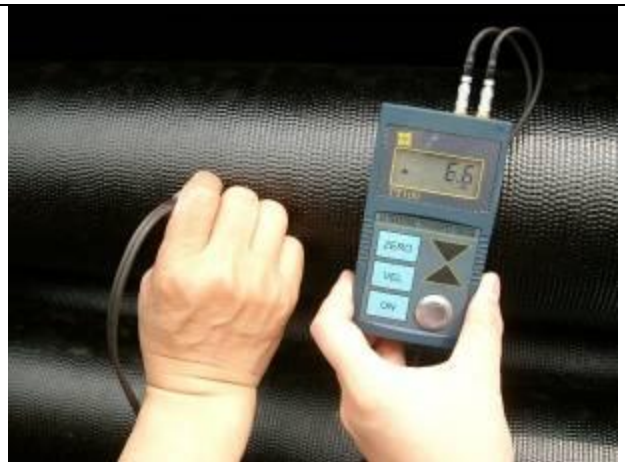
Wall thickness checked

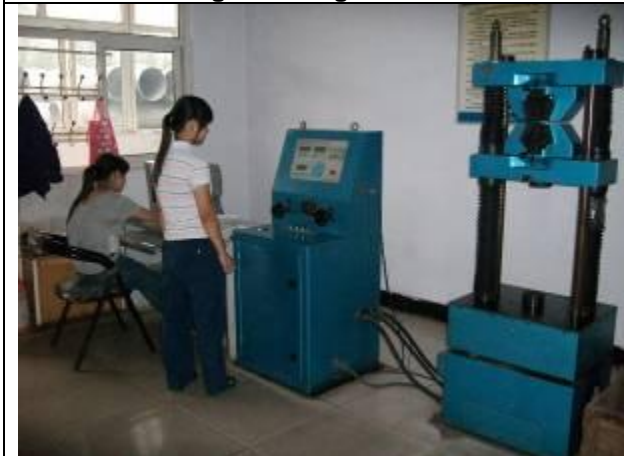
Pipe No.	Actual tested data		
	Tensile strength (Mpa) ≥420	Elongation (%) ≥10	Hardness (HB) ≤230
090702CA-328-31	460	14	169
090702AA-187-33	473	14	170
090703BA-45-35	451	15	169
090703BA-259-37	446	15	171

Result: Passed.

Mechanical properties test

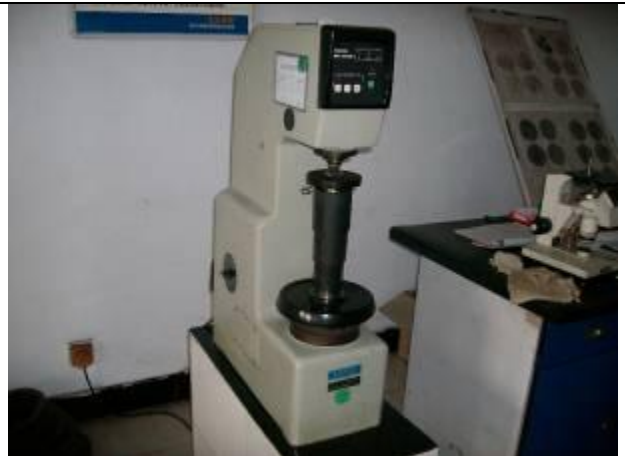
Hardness check
