Inspection Order No.: IN-TJ-5301-12116-03

**INSPECTION REPORT**

Ductile pipe DN450 / 784pcs Ductile pipe DN500 / 1667pcs

This is to report that we, SGS-CSTC (Tianjin) Co., Ltd. at the request of SHANXI SOLID INDUSTRIAL CO., LTD. conducted the following inspection:

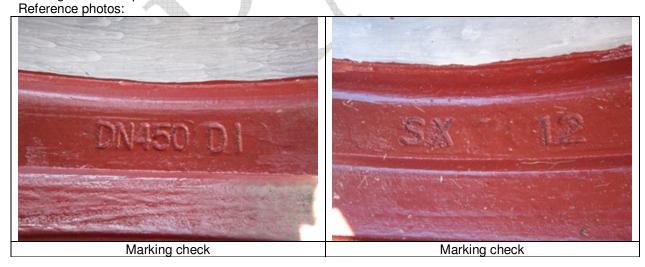
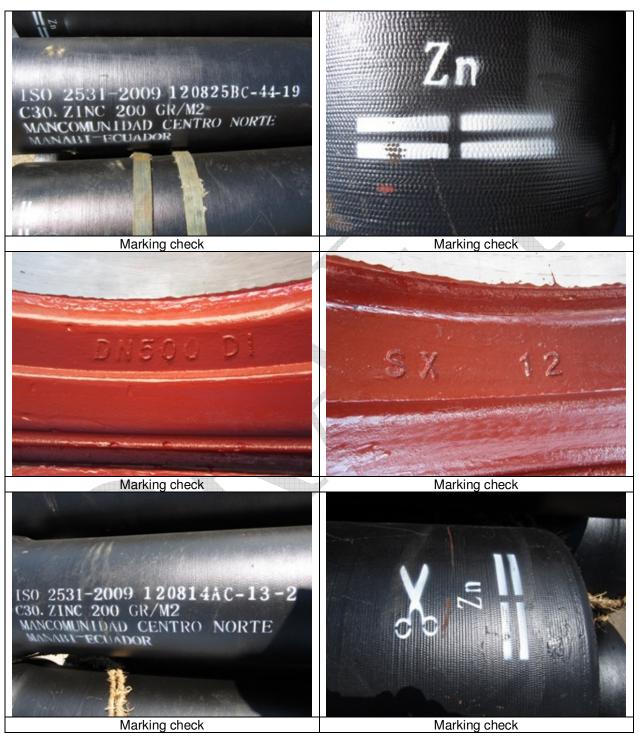
Marking check was performed and details as follows.

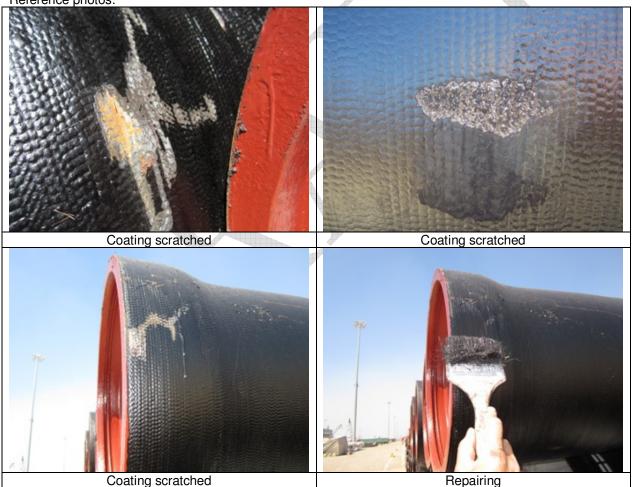
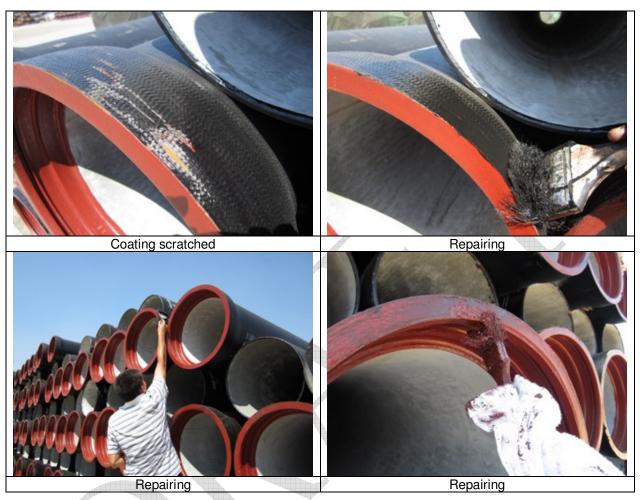
Reference photos:

During the inspection visual quality check was performed, found the cargos were stacked on the open-air storage. The pipes were found painted with black paint on external surface and lined with gray lining on internal surface, the socket of the pipe was found painted with red paint on internal surface.

- During the inspection, a part of pipes were found coating scratched on the surface. The supplier repaired imperfect pipes with black paint and red paint.
- The result is subject to buyer's evaluation.
